**U.S. Environmental Protection Agency
Vasquez Boulevard I/70 Superfund Site
Replacement Certificate**

LBP Assessment Results

Property ID # 3429 / 3830 Franklin St.

SITE NAME: VASQUEZ BOULEVARD AND I-70

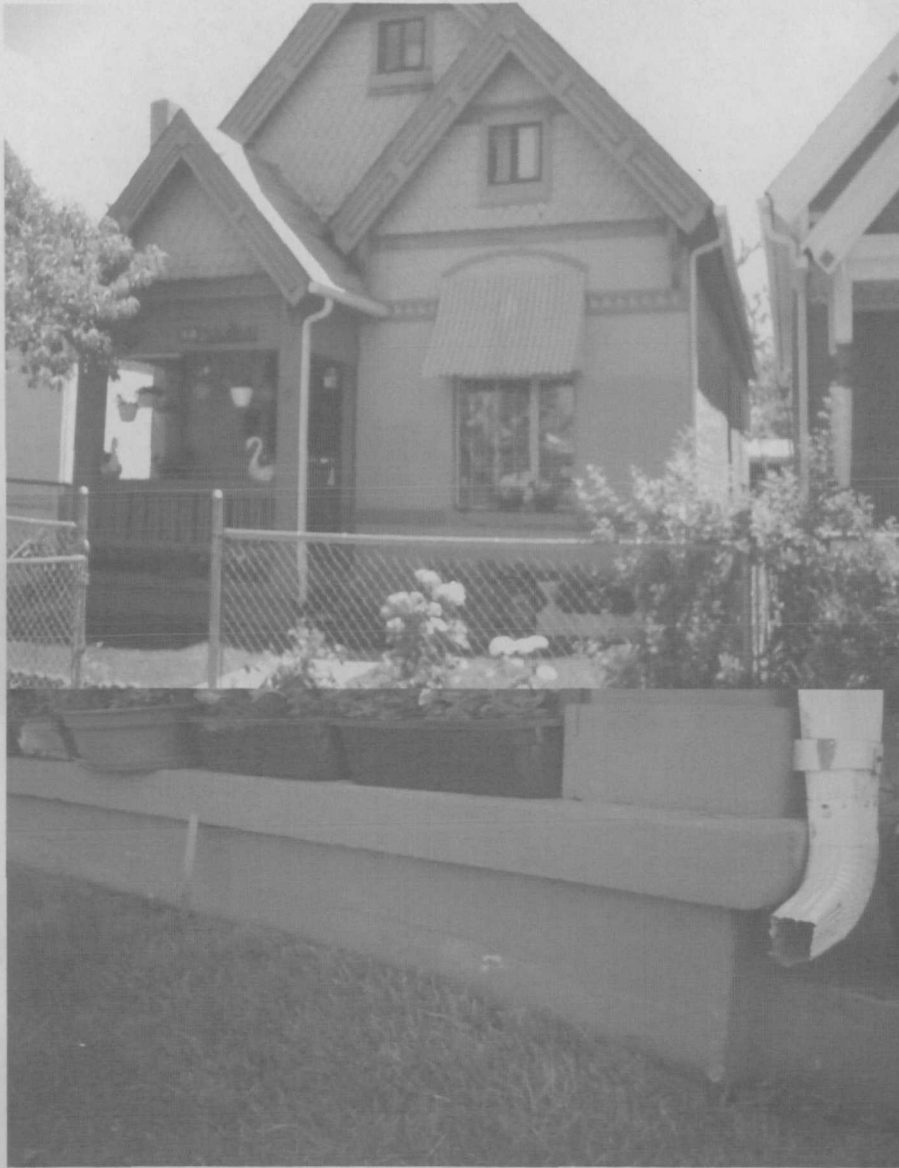
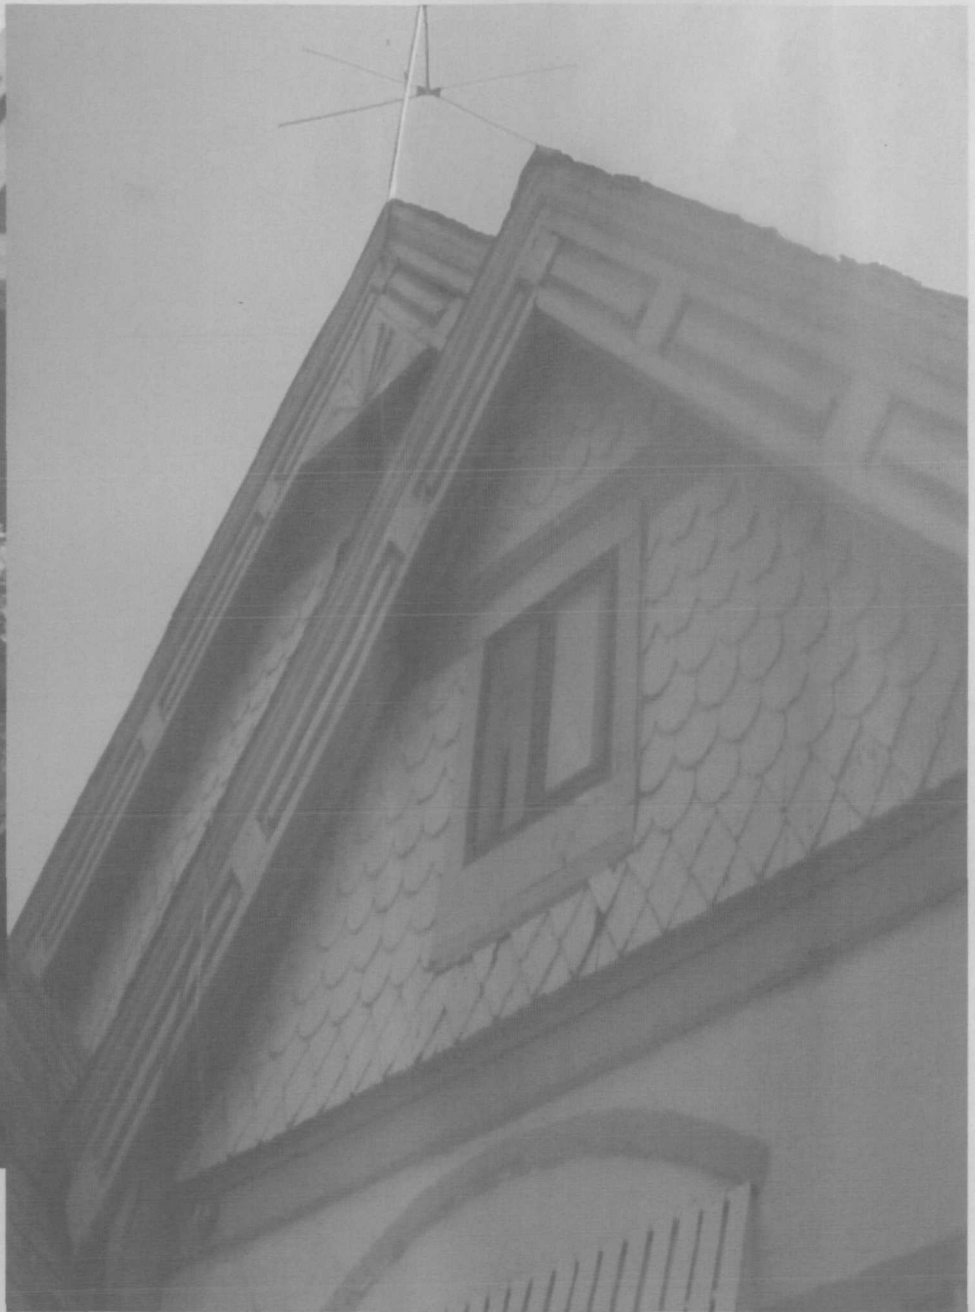
- HOUSE IS POSITIVE FOR LEAD, BUT THE PAINT IS IN GOOD CONDITION ON ALL EXTERIOR WALLS

.Foundation of front porch is contains lead paint &
showing signs of chipping
2nd level awnings, trim, wood siding in poor
condition and contain lead paint

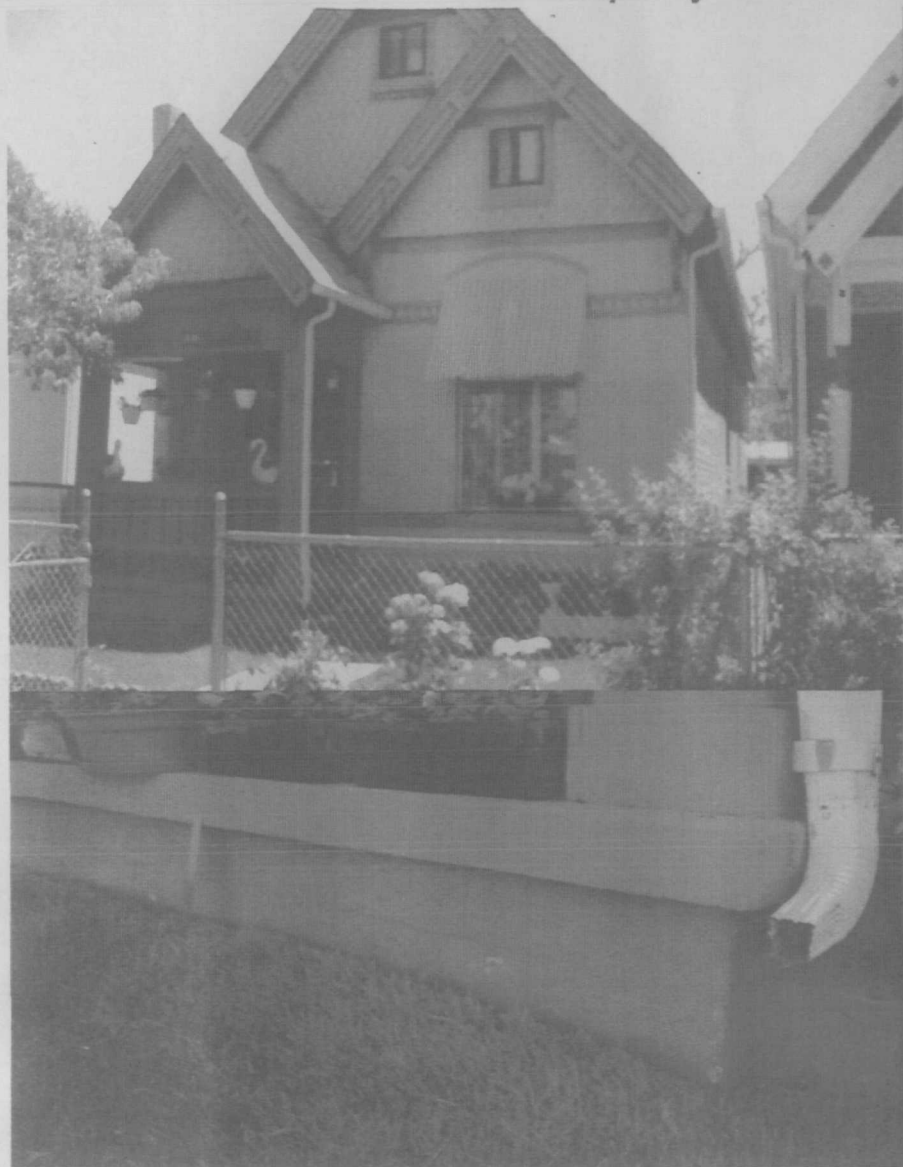
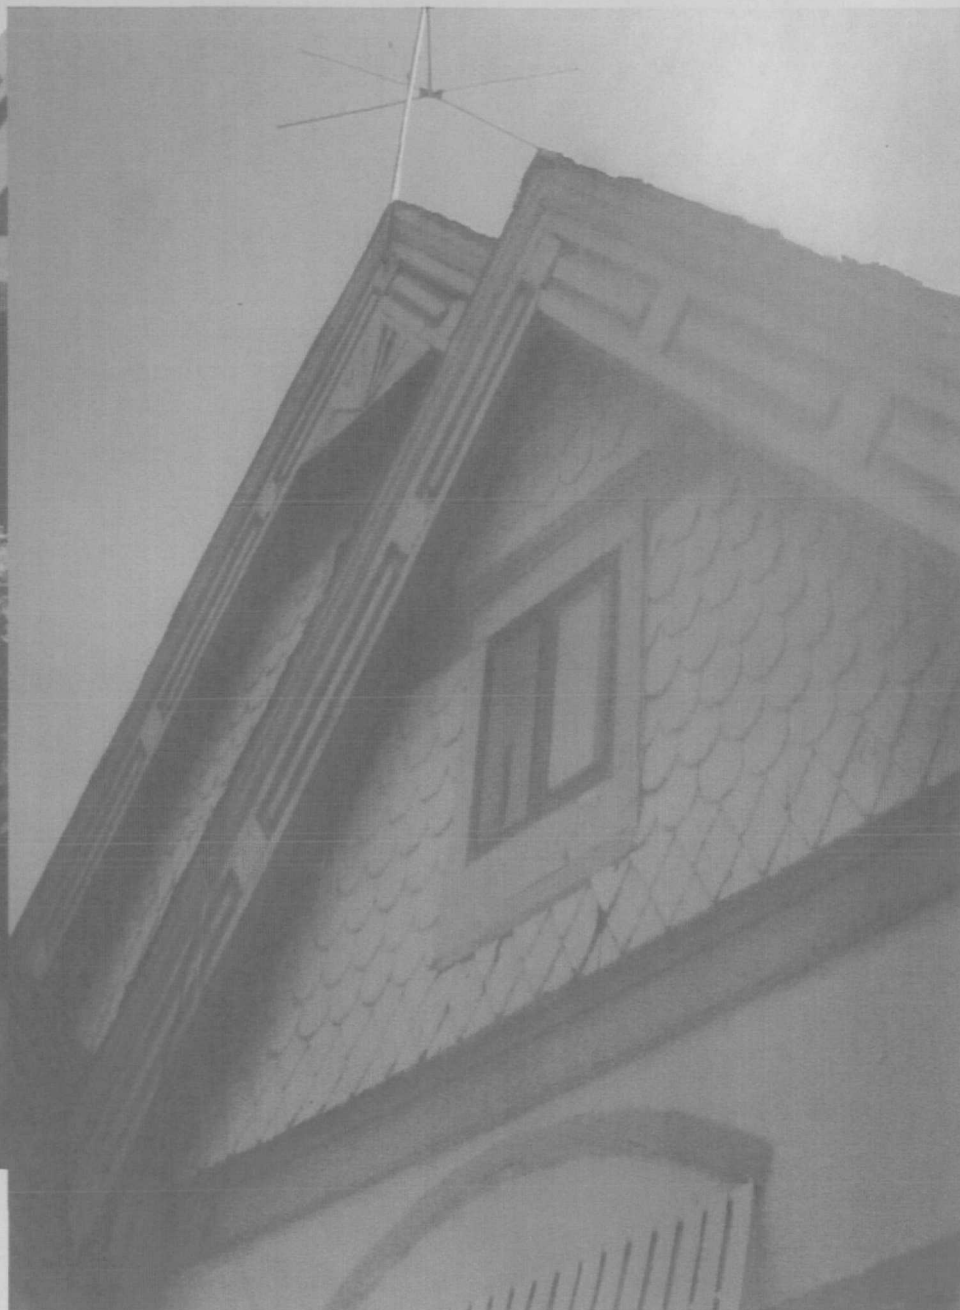
Property ID # 3429 / 3830 Franklin St.

- HOUSE IS POSITIVE FOR LEAD, BUT THE PAINT IS IN GOOD CONDITION ON ALL EXTERIOR WALLS
- 2ND LEVEL AWNINGS, TRIM, WOOD SIDING IN POOR CONDITION & CONTAIN LEAD PAINT
- FOUNDATION OF FRONT PORCH NEAR LAWN IS LEAD POSITIVE & SHOWING SIGNS OF CHIPPING

Foundation of front porch is contains lead paint &
showing signs of chipping
2nd level awnings, trim, wood siding in poor
condition and contain lead paint
